ARCHLAB ACCESS REPORT

Title of the ARCHLAB TNA Project: Yellowish Gypsum Efflorescences on Wall Paintings from the 14th Century in the Cathedral of Schleswig in Northern Germany

Project Acronym: GypsEffSchleswig

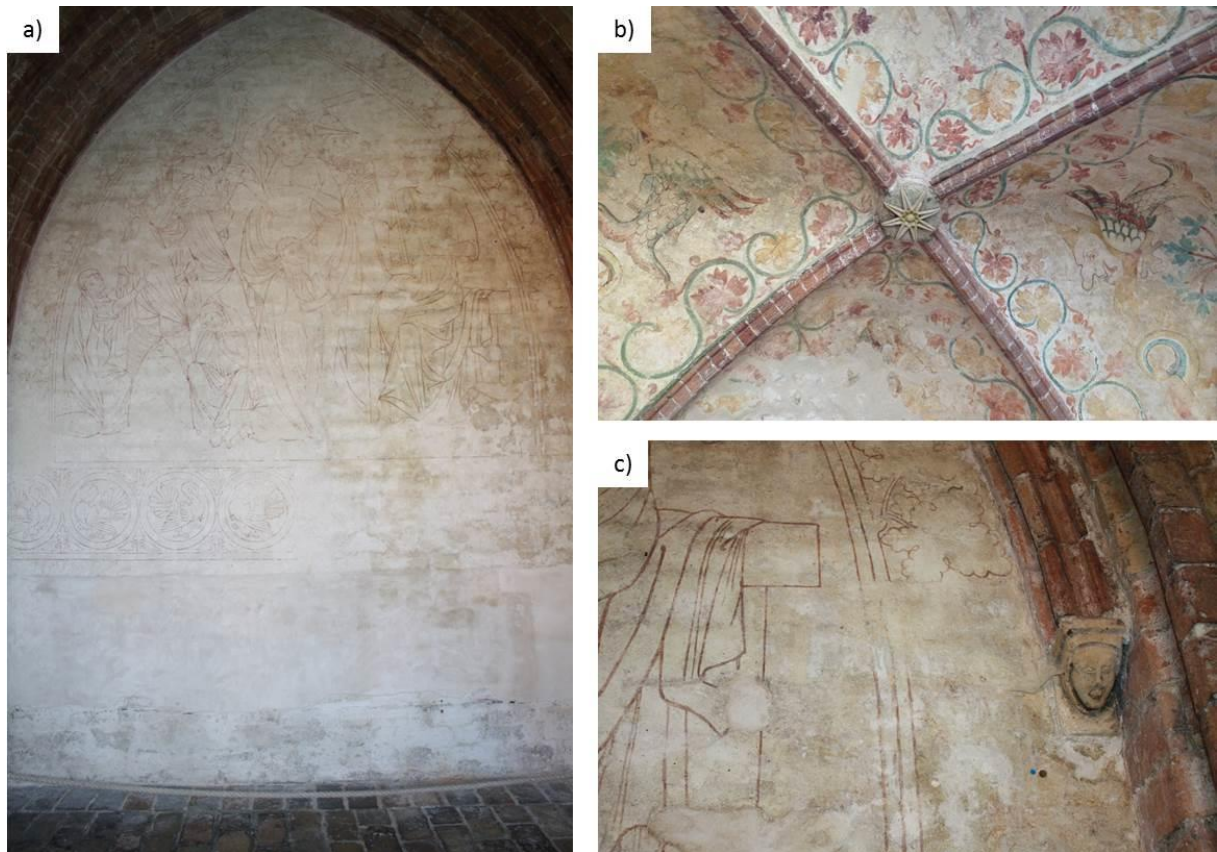
Figure 1: Photographs from the *Schwahl* in Schleswig. a) bay no. 5 showing the murder of innocents in Bethlehem b) example for the polychrome decorated vaults c) detail of bay 5 with an extreme presence of yellowish encrustations on its surface.

At the beginning of the DBU project it was known that the bays suffered from yellowish crusts whose extend varied from bay to bay, affecting not only the aesthetic appearance. Also damages in form of scaling and partly losses of the painted layer were observed. In depth behind the painted layers most of the bays were affected by salt contamination, especially by nitrates and chlorides. Due to a very humid and consequently advantageous climate the salts remain dissolved most of the time. In the past, from 2010 to 2013, the object was investigated and a high enrichment of gypsum on the surface of the wall paintings was detected, leading to the assumption that the yellowish crusts are a result of gypsum encrustations. After a restoration and consolidation with the barium method the yellowish crusts returned quickly even though salt contents in the first centimetres and the gypsum enrichment were initially reduced directly after the procedure. The DBU project should investigate the situation of the wall paintings to establish a suitable conservation concept for the object which is an important part of the German cultural heritage from the Middle Ages. Parallel to lab experiments with the goal to investigate the influence of hygroscopic salts on the (re-)crystallisation and the damage caused by gypsum as well as its mobility, the influence of the crusts on the moisture content and hygric behaviour of the walls should be investigated, to name only two of the main objectives treated in the project.

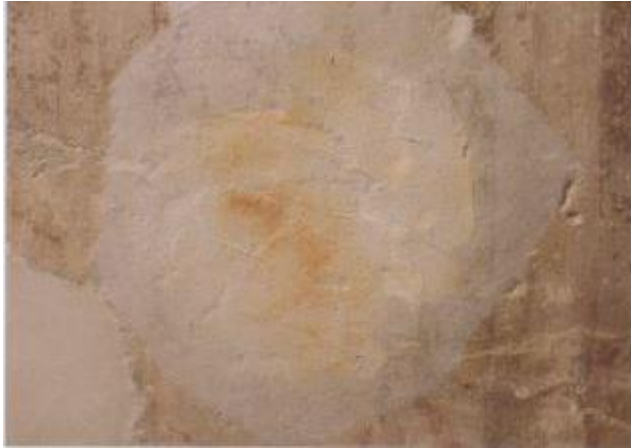
Figure 2: Yellowish patina on wall paintings in the “*Cappella della Maddalena*”; photo taken from [4].

A yellowish patina was also observed in the “*Cappella della Maddalena*” in the National Museum Bargello in Florence (Figure 2). These wall paintings are dated to the 14th century and were executed by Giotto and his workshop. Also in this case organic materials introduced in past conservation interventions as fixatives (acrylic resins) would have provoked the patina, since it might be dissolved by water and other treatments when they penetrate the *intonaco*. To prevent interactions of agents used for cleaning and pigments or binders as well as dissolution of organic materials responsible for yellowish patinas only a small amount of solvent should penetrate the wall paintings. As an alternative to cellulose an acrylic polymer, “carbogel”^[2], was used in parts whose conditions allowed it. The material shows a high retention of the solvent (here ammonium carbonate solution) and can be

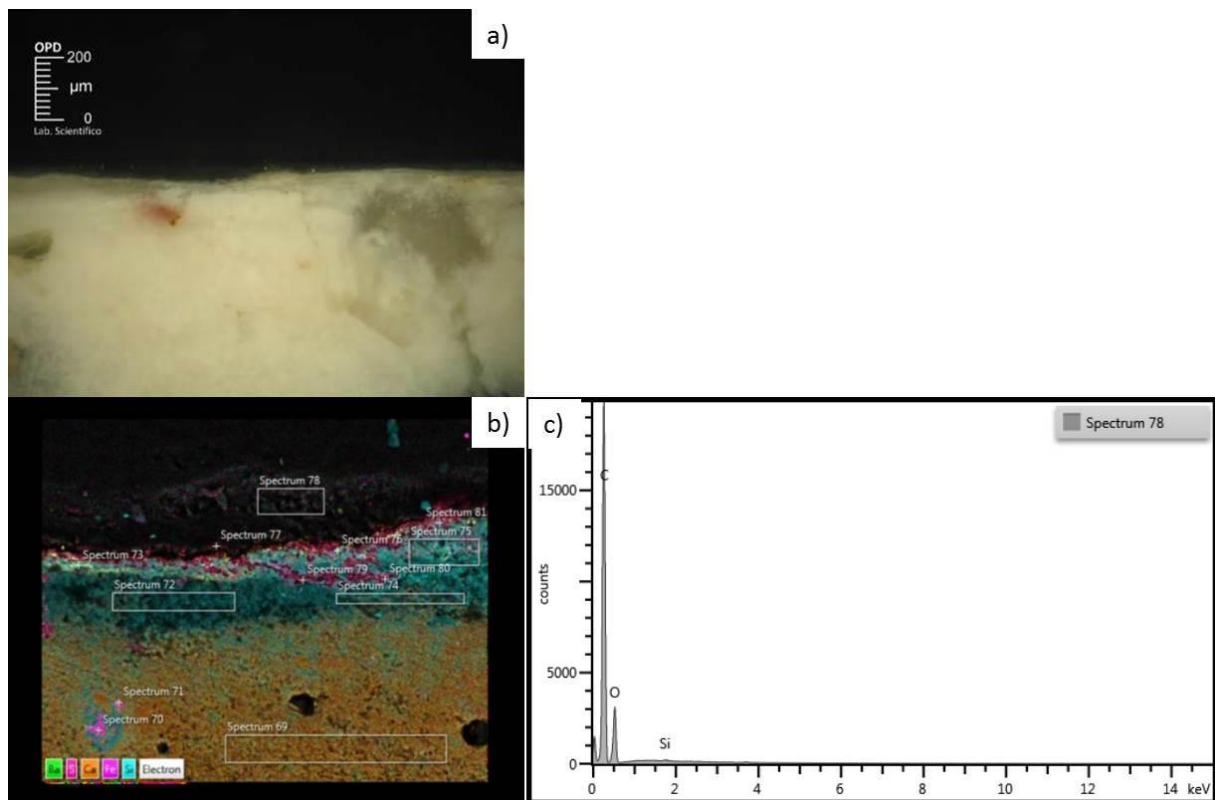
Figure 3: Sample from the *Schwahl* in Schleswig analysed at the OPD a) image from the stratigraphic analysis; b) image of the investigations with SEM with an outermost layer which is only vaguely recognisable; c) X-ray spectrum from this outermost layer showing the presence of an organic material. Figures taken from [13].

A special advantage during the visit of the OPD was the possibility to analyse some samples from the wall paintings in Schleswig with experts, Carlo Galliano Lalli and Federica Innocenti, from the Opificio. Investigated samples were taken from the *intonaco* in unpainted areas in two different bays of the cloister, one of them showing no evident encrustation and two with an extreme discolouring on the outermost layer. With the knowledge and expertise of the experts results of performed stratigraphic analysis (with optical microscopy) and investigations with scanning electron microscopy with energy disperse X-ray spectroscopy could be discussed directly and invaluable results and conclusions could be drawn. It was confirmed that also in the case of yellowish crusts on the wall paintings in the *Schwahl* organic substances are present (see for example Figure 3). Gypsum was not detected in the yellowish areas on the surface. Of course a superficial enrichment of gypsum was detectable but no sulphur or calcium was present in areas of the described crusts. Barium could be identified in parts of these areas but barium sulphate (originate from gypsum transformations performed in the years between 2010 and 2013) is not the only component. This became evident in element mappings. Besides, sections that were identified as the outermost layer and as the described crusts with optical microscopy were only vaguely recognisable in SEM images (Figure 3). A reason for that is the presence of mainly oxygen and carbon in organic materials. These rather light elements lead to darker areas in the images due to a weaker backscatter of electrons.

Even though the initial suspicion formulated in the application form has been disproved and gypsum is not the origin of the problem, an explanation was found during the visit at the OPD, thereby opening the way of finding solutions to cure the object and to preserve this piece of cultural heritage. Now these findings must be discussed with the participating restorers in Germany to make decisions concerning further procedures.
