ARCHLAB ACCESS REPORT

THE TWO PORTICOS DE LA GLORIA, RESEARCH AND CONSERVATION

Project acronym: 2PORTRECONS

User: Victor Borges. Senior sculpture conservator. Victoria and Albert Museum.

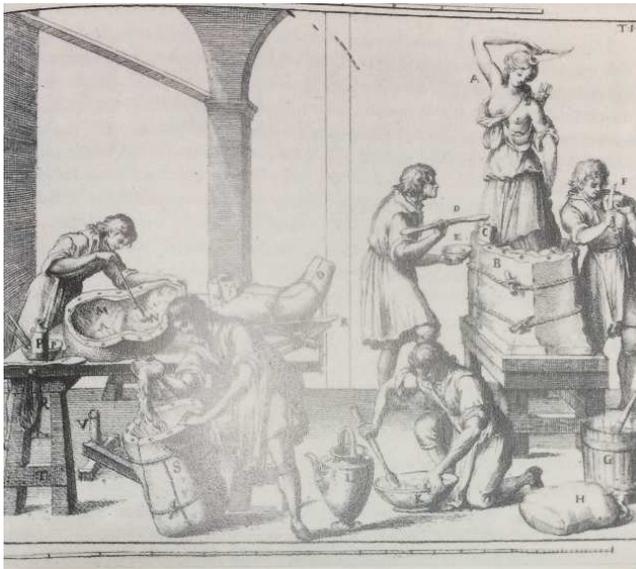
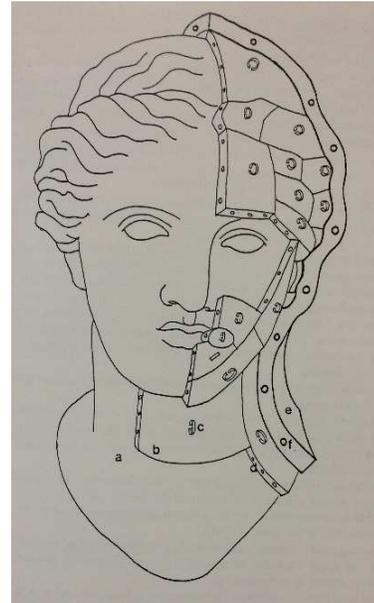
This book was an useful reference to the traditional methods of casting. Particularly the system of plaster piece mould that Brucciani used very likely. Some of the images were very self-explanatory of this method.

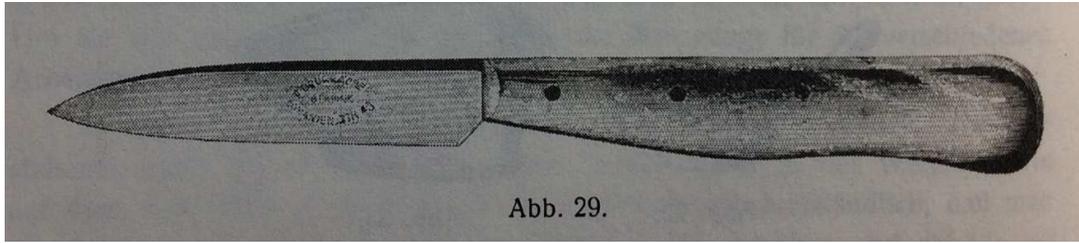
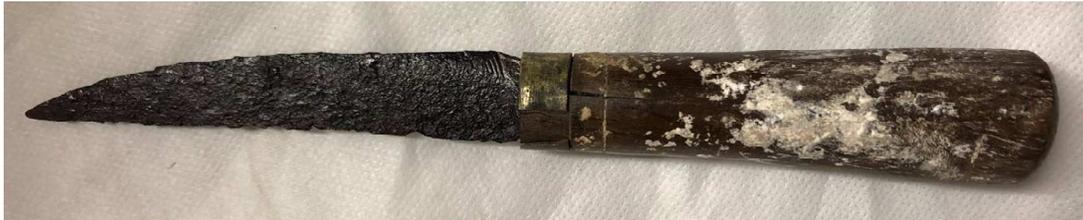
There is a reference to the gipsmesser or plasterers knife. A tool that would have been used to shape the plaster pieces of the mould and to release them from the surface of the Portico. This knife is very similar to a knife found by the conservators in the original Portico behind a figure approximating us even more to Brucciani's technique.

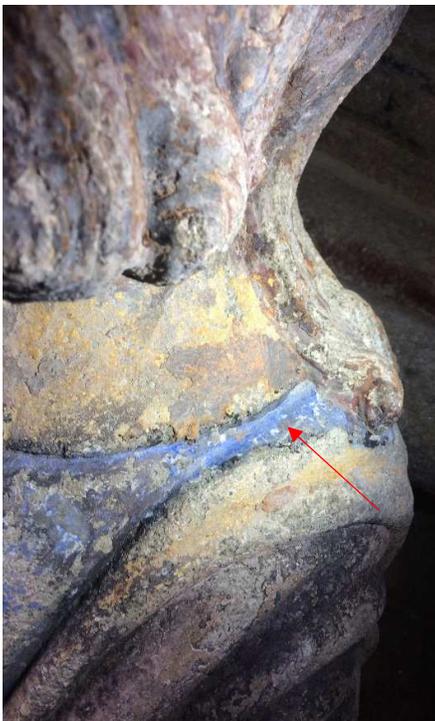
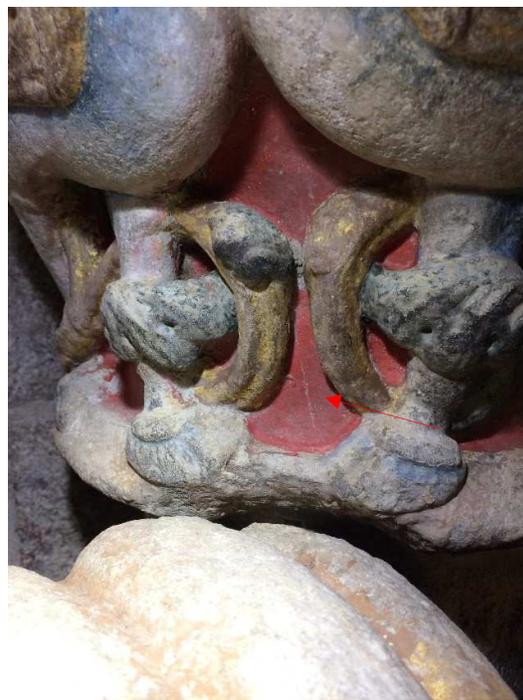
These knives were the tools that probably left these marks in the Portico whilst forming and separating the plaster piece moulds

Many incised lines were also observed on the paint layer. This is the consequence of using sharp tools, such as the plasterer's knives to shape and release the plaster pieces for the mould (Pag.7 & 8)

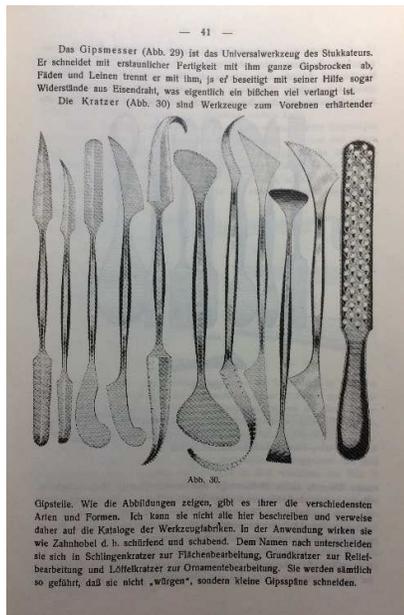
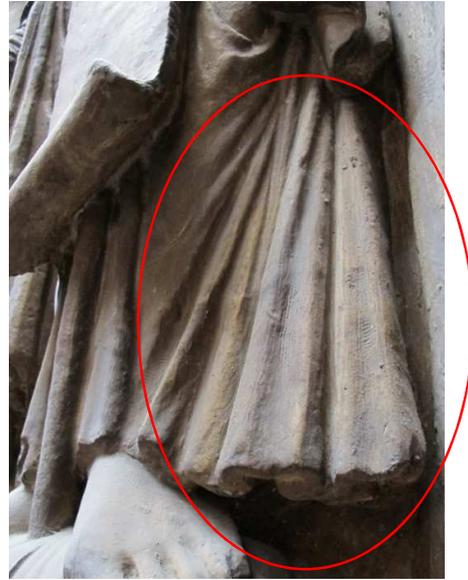
The book shows other traditional tools that probably Brucciani and his team used to rasp the surfaces of the cast to remove imperfections

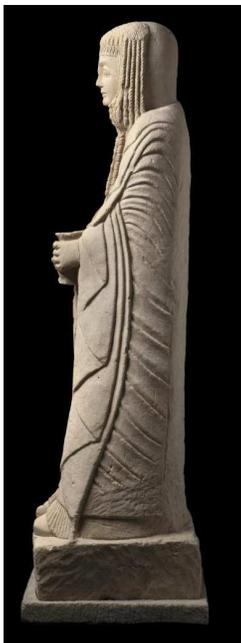
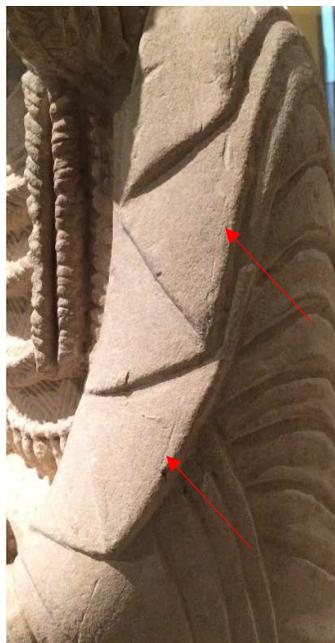
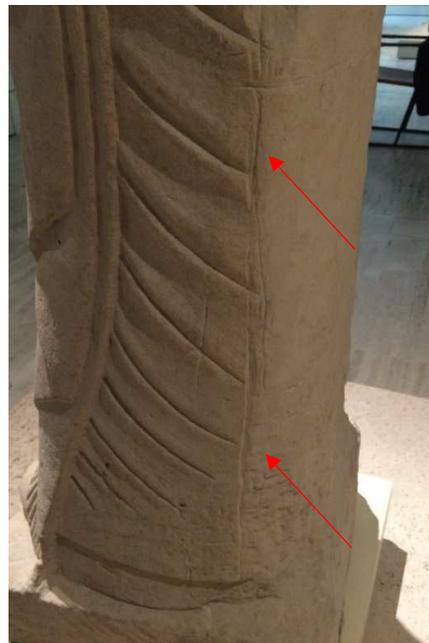
This reference provides us with another contemporary used of moulds to Brucciani's work. This sculpture in the National Museum of Archaeology had a mould taken in the late 1800's and shows the same straight incisions from plaster knives. Also, fibres were found on the surface during the conservation work, similar to the technique Brucciani apparently used to protect the surface of the Portico

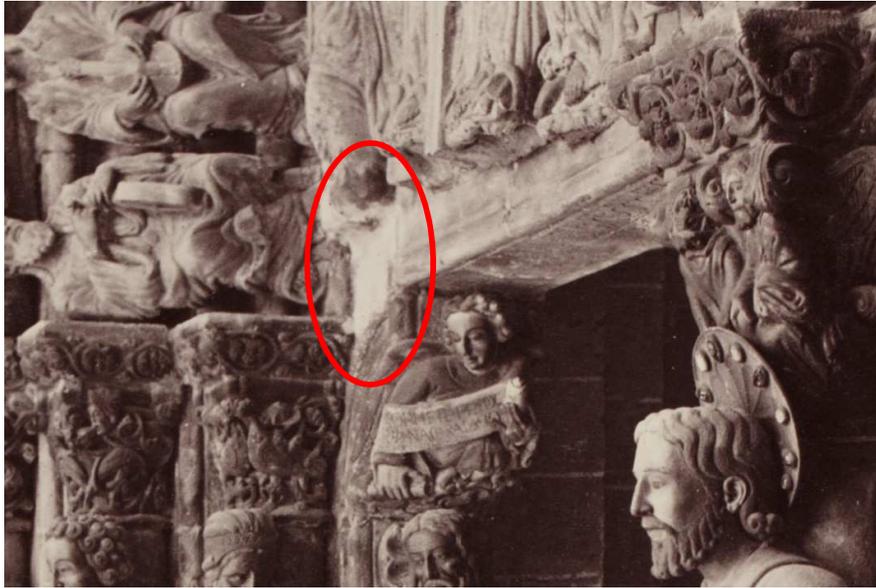
- Ward. Michael, Studies on the Portico de la Gloria at the Cathedral of Santiago de Compostela, Doctor Philosophy dissertation, University of New York, February 1978
We found together this interesting reference, where the apparently the author identified the supposedly restoration Brucciani carried out in the Portico before or during the moulding process, as it is also mentioned in the historical records. One of the possible areas is the lower left side of the Tympanum as appears in the Charles Thompson photograph from 1866.

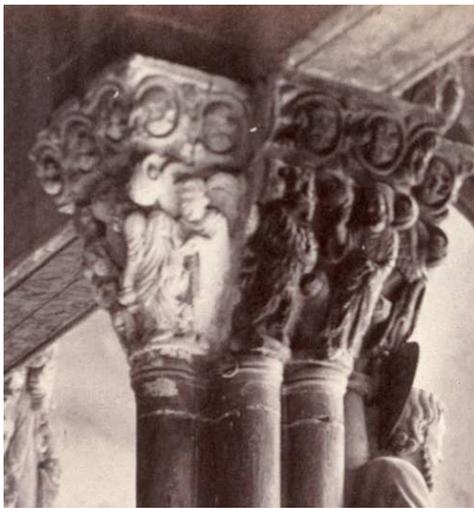
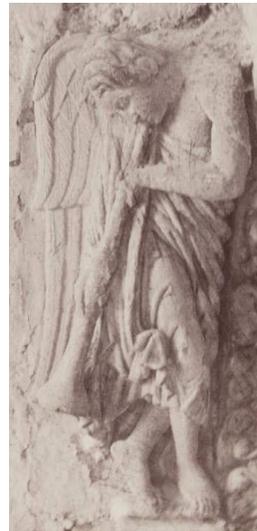
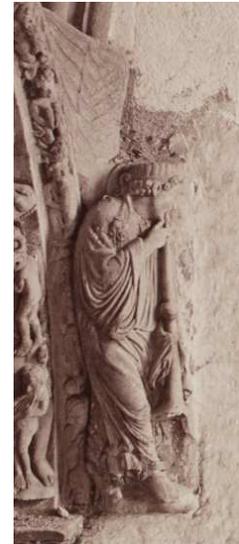
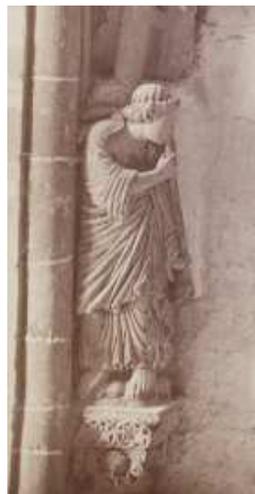
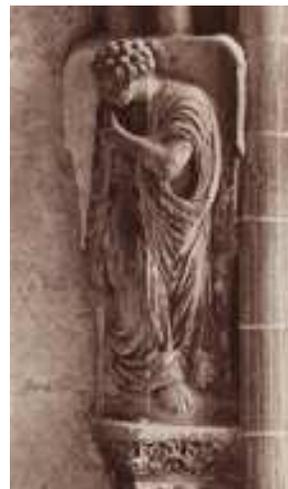
- The top capital of central mullion or parteluz appears white washed at the back. Brucciani also did make a mould of this side of the Capital. The wings of both trumpeter angels connecting to the walls appeared whitewashed. The same happens to figures at the opposite side of the loggia.

This could have led to the loss of polychrome as it seems these areas were treated as part of the walls not integral part of the Portico.

The back side of the capital in fact has lost all traces of paint.

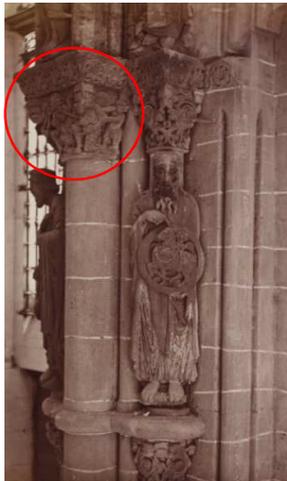
Thompsons photo1866

- Thanks to the collaboration with the IPCE team a new cast of the Portico was found on the V&A collection from the surrounding architectural setting of the Portico. It was found through the observation made on the Thompson pictures, the images of the Portico in its first installation in the Museum and the actual Portico.

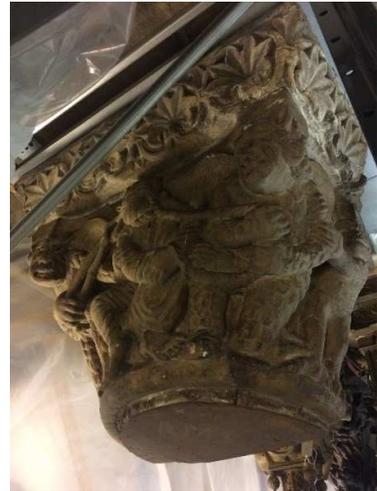
Cast of capital found in stores

This capital probably got separated from the rest of the cast after the portico was moved to its final location in 1873, it was then mislabelled and stored since. The most relevant find is that in the phot taken by Thompson we can see the residues of plaster from the piece mould, and from the clay used to block the recesses by Brucciani’s team. There was no previous evidence that any casts were taken from the opposite side of the Portico.

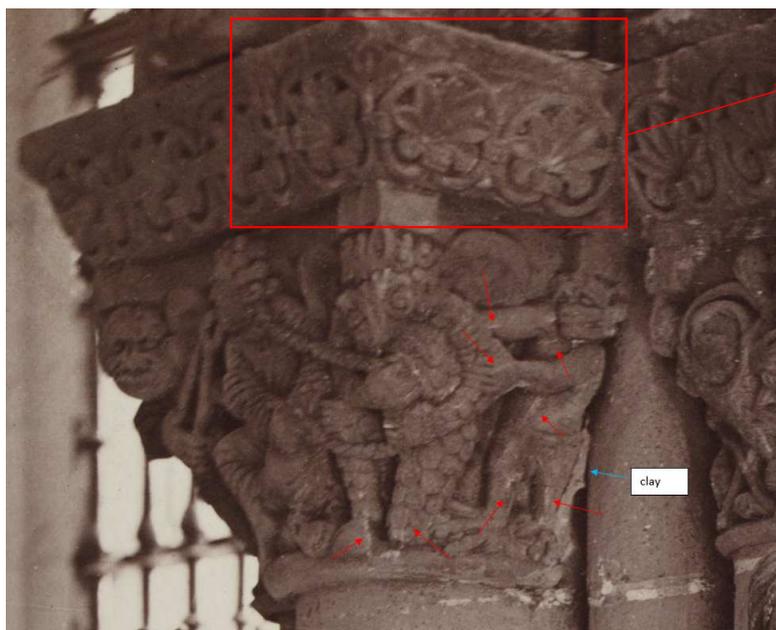
just this section of the moulding was cast. Plaster residues can be seen on this area

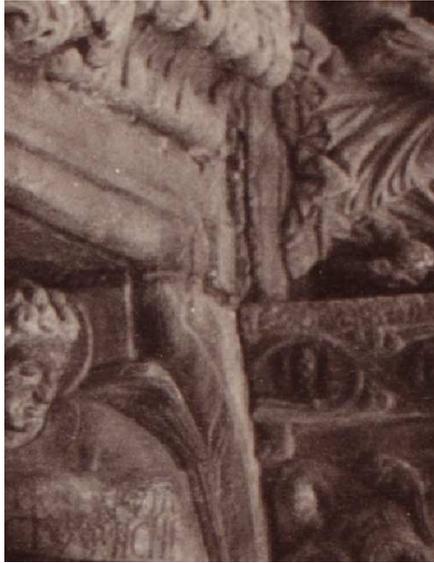
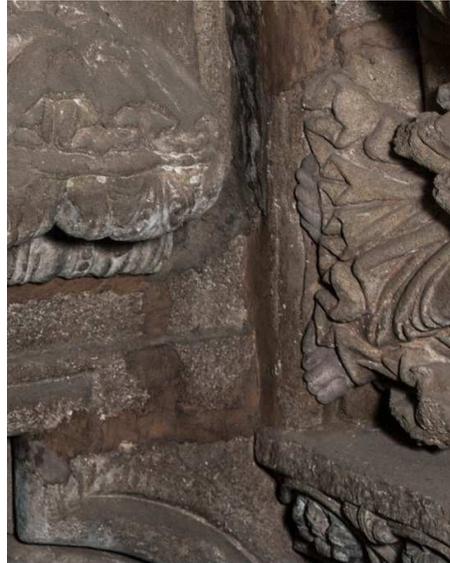
- The crack the right lower corner of the tympanum appears filled with mortar in the original Portico hence later than Brucciani's intervention.

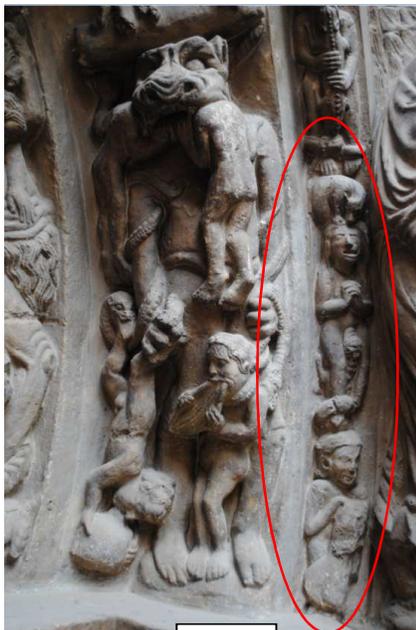
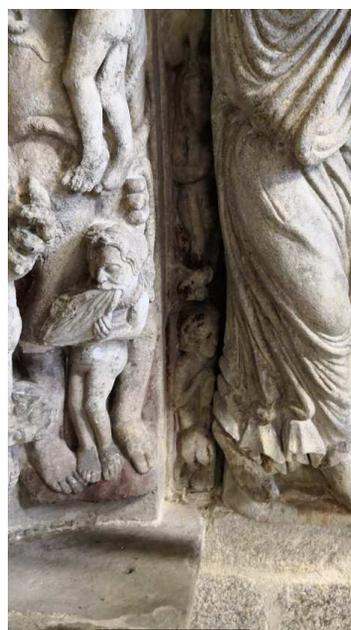
- The small figures on the outer part of the right arch where meets the trumpeter angel show in the cast much more exposed than in the original where the figure is almost completely hidden by the angel. These figures seem to be partially reinvented in the cast as the originals could have been very difficult to mould.

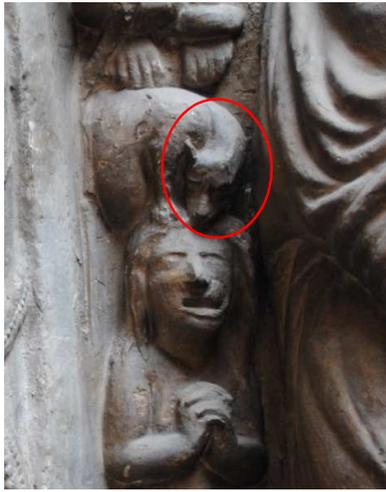
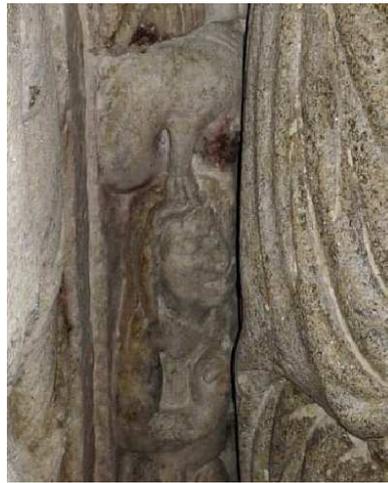
The head of the animal on top of the female figure has the head to the right instead to the left as it appears on the original

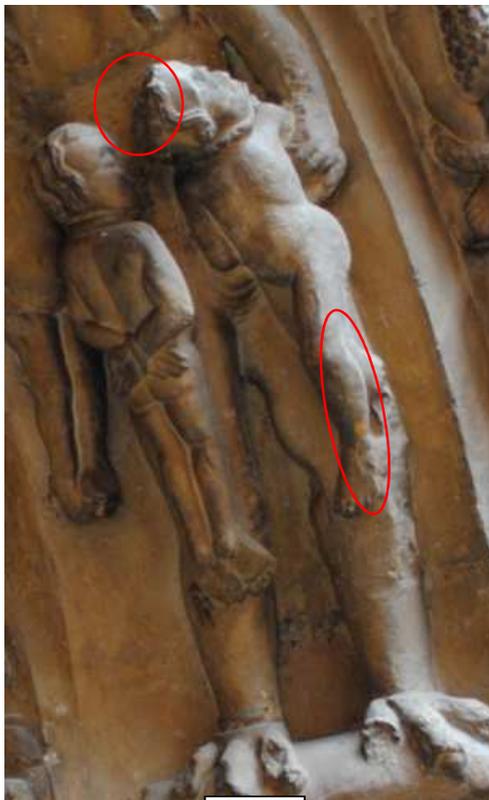
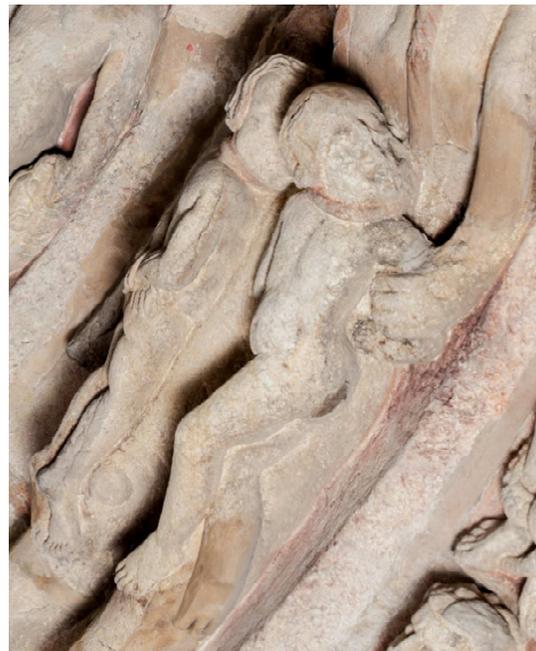
- There are no reconstructions on the cast figures hanging from the ropes to the right of right arch.

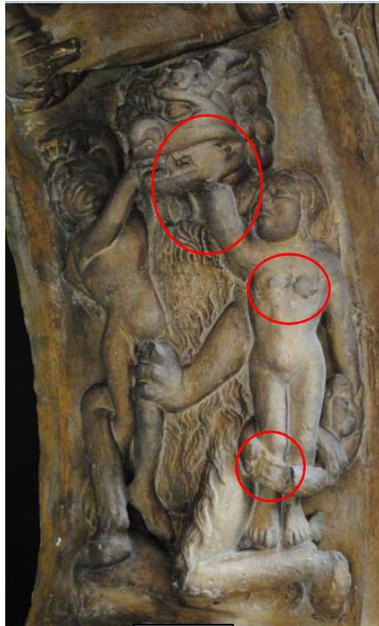
CAST

- Also, there are no fills in the demons on the right arch Such as the demon that is eating the hand to the figure, these areas showed reconstructed in the Portico.

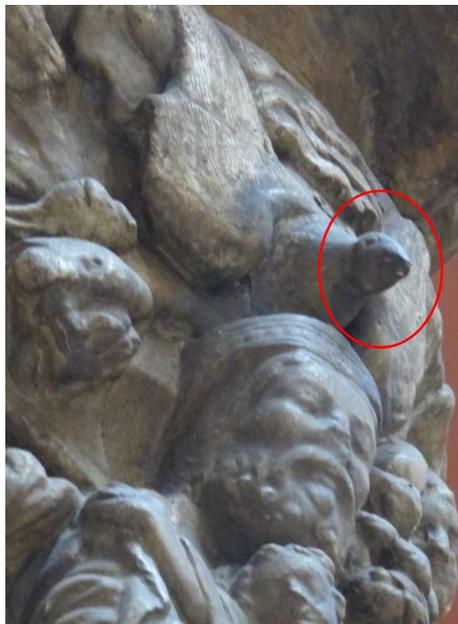
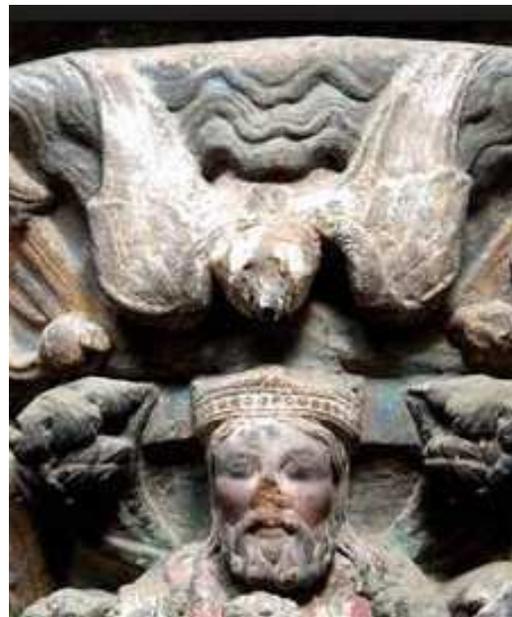
- The dove, part of the Trinity in the lower capital to the central mullion, appears on the cast and the Thompson pictures but not on the original Portico. This was, on the original Portico, a plaster reconstruction with a copper dowel that was removed as it was very degraded and the head of the dove lost.

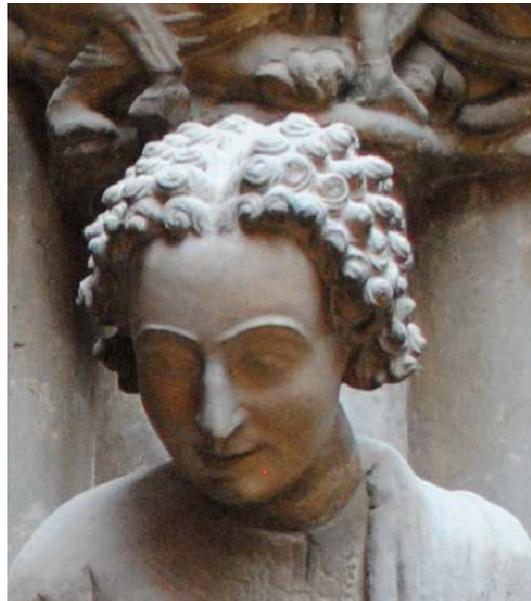
- The figure of St John on the pier to the right of the tympanum shows good definition in the curls and the head shows in the same angle as the cast. The reproduction despite the surface work is of good quality.

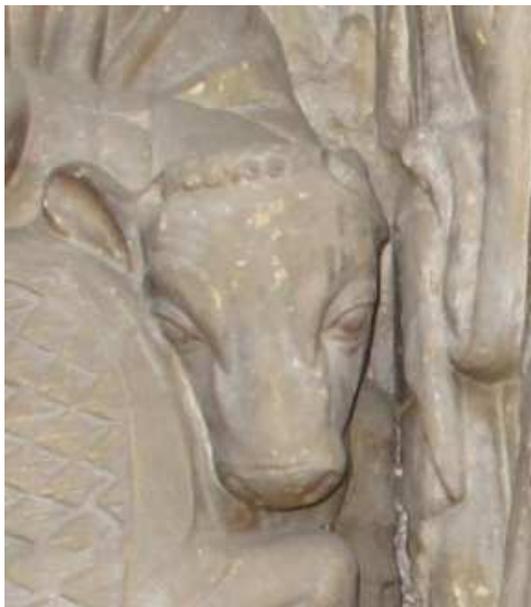
- The attribute of St Luke, the winged bull in the tympanum, has no horns in the cast but there are in the original, hence this are also later reconstructions

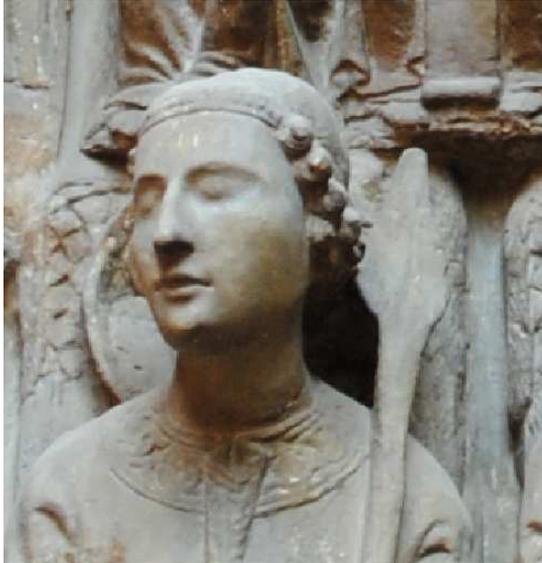
- The spear blade, on the instruments of the passion held by an angel on the tympanum seems different in the copy. Perhaps this area was difficult to mould and was simply reconstructed in the cast?

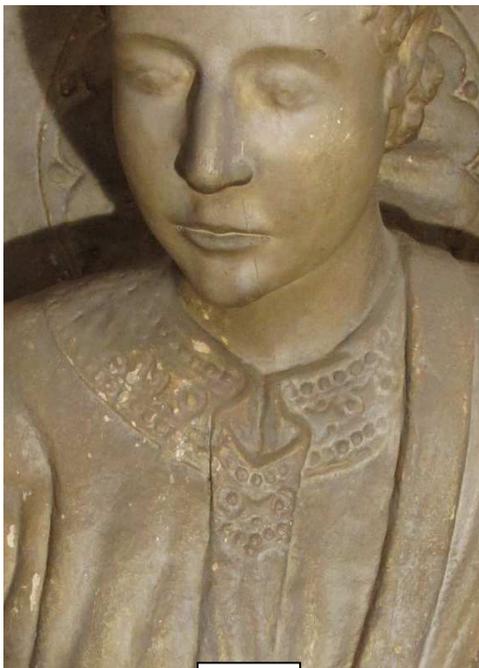
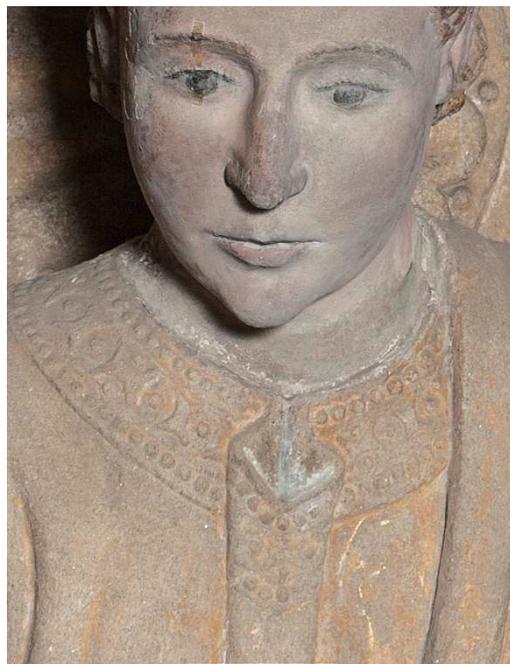
- The carved brocade on the evangelists have quite good definition on the cast, highlighting the quality of the moulds

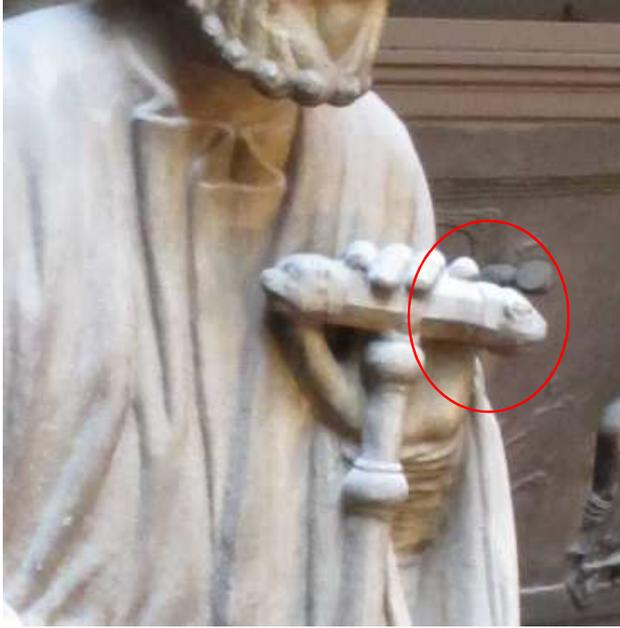
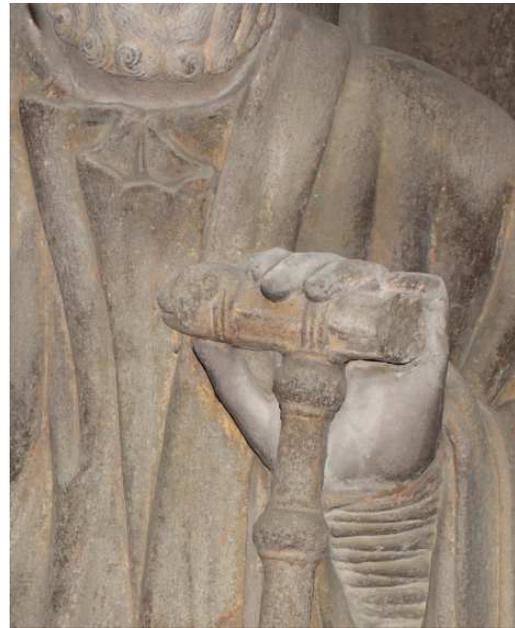
- The head of the staff that the figure of St James in the parteluz is holding appears complete in the cast, the original has one of the animal heads and a finger missing. These parts also appear on Thompson’s pictures.

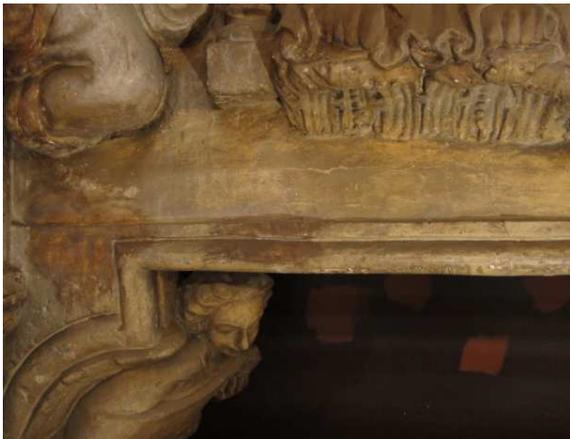
CAST

- The lintels that supports the tympanums is wider in height than in the original. The reason being technical because the tympanum in the cast is supported on metal girders which support the whole structure. The plaster cladding had to hide this structure hence the size.

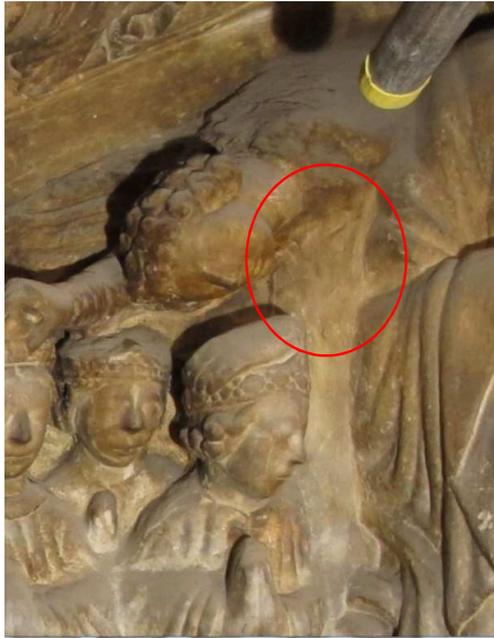
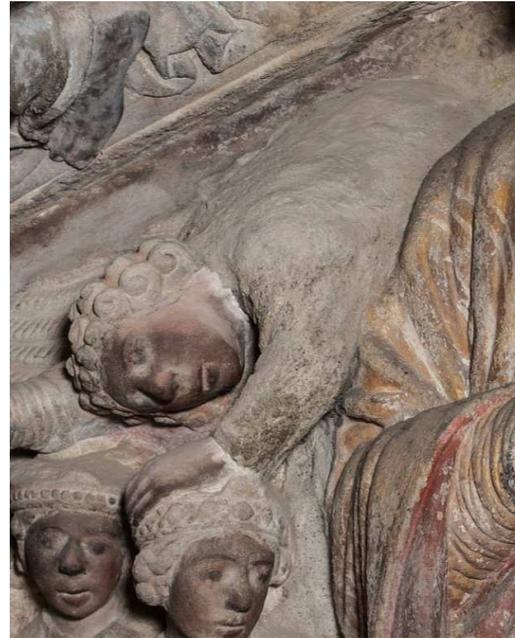
- The angel to the top left of the tympanum, laying crowns has the left arm missing on the cast, the one in the original seems to be a later reconstruction

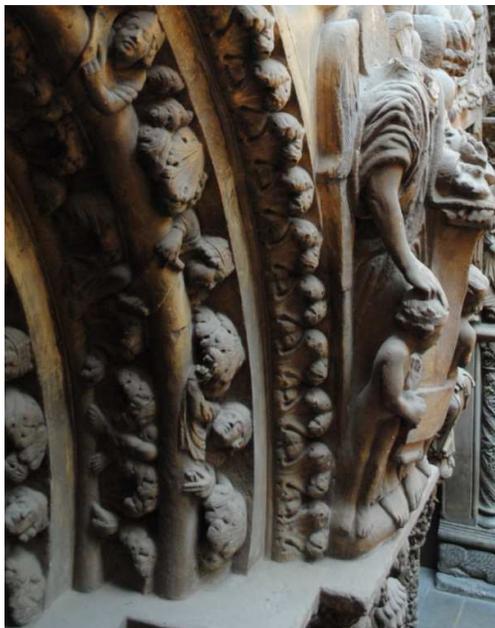
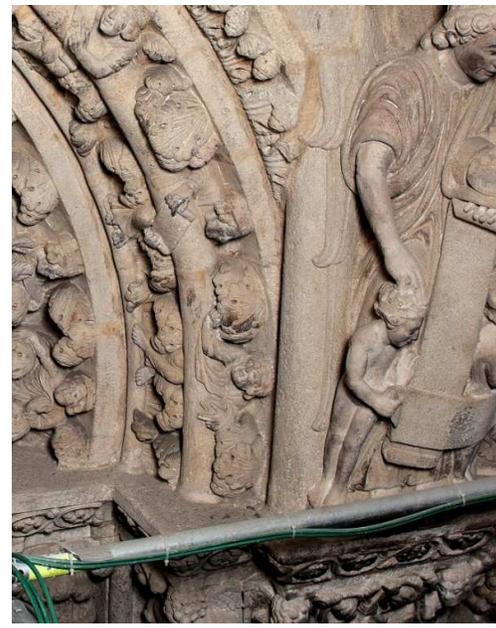
- The left arch has a different ending at both sides in the copy where the acanthus leaves go all the way along its perimeter. However, on the original these leaves are not present to the right and to the left show very flat and partially cut.

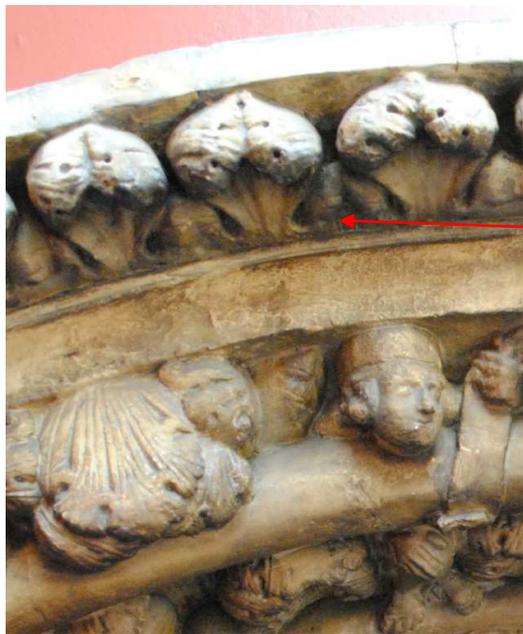
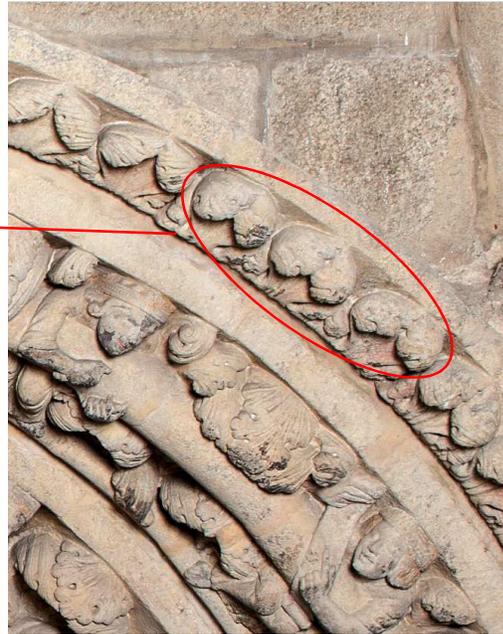
- The acanthus leaves on the cast show a level of repetition, there is no variety. Seems that Brucciani just moulded a section of three leaves and reproduce it around the whole of the arch with one mould.

The acanthus leaves on the outer side of the left arch show in the portico with quite a lot of depth even showing the drilled holes

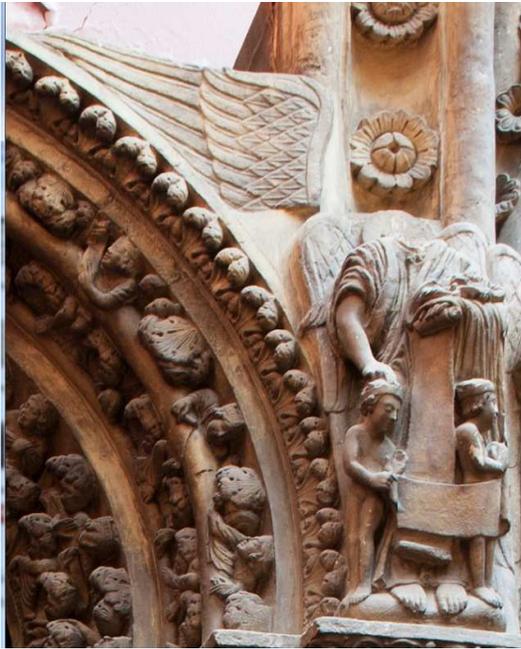
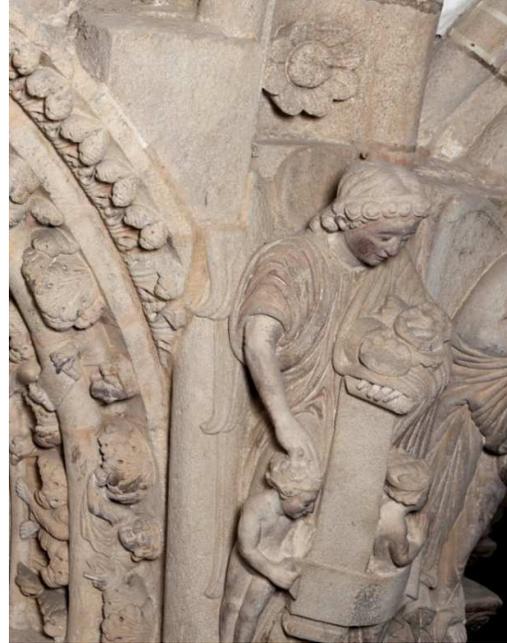
- The angel to the right of the left arch has an extra wing in the cast. There was an attempt to make the Portico more symmetrical. This angel now appears with 3 wings in the cast.

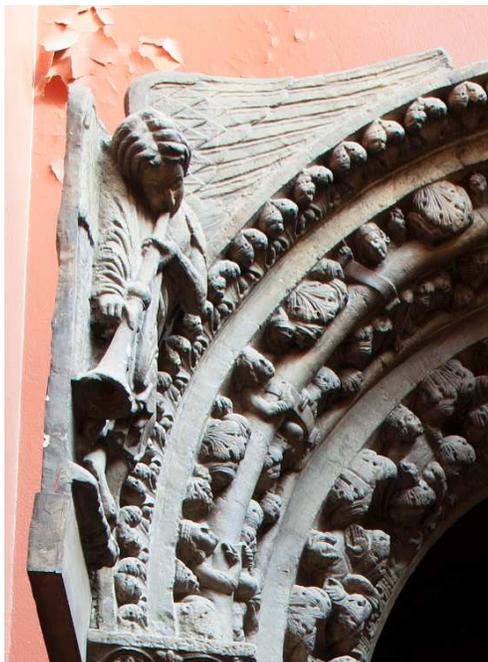
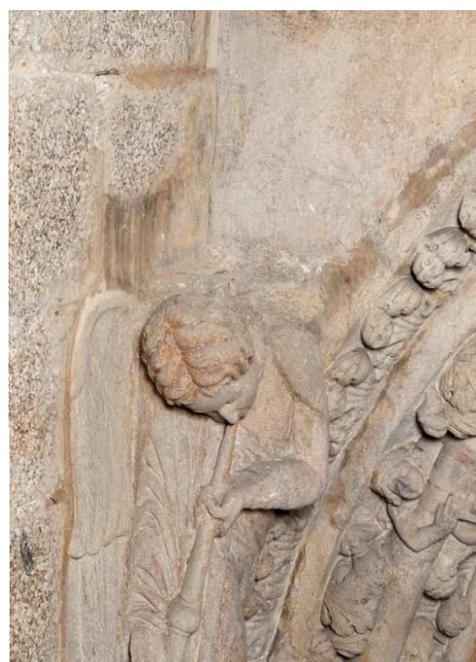
- The trumpeter angel to the left arch has an extra wing in the copy not on original.

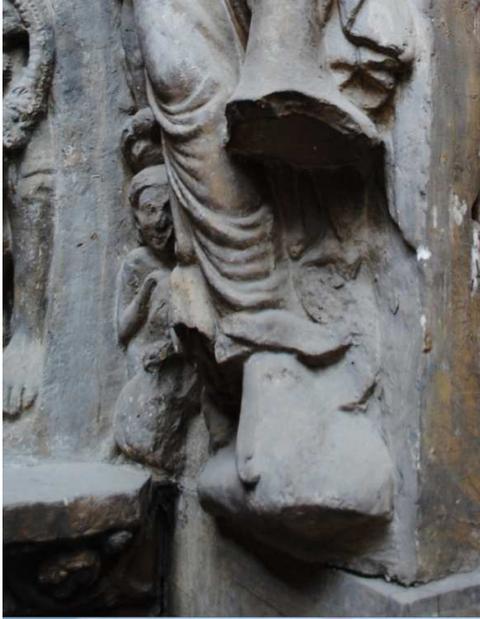
CAST

- There are losses on the Trumpeter angel on the right arch that appear both in Cast and copy. This shows that there are losses pre-1866. Although the fill on the foot seems later.

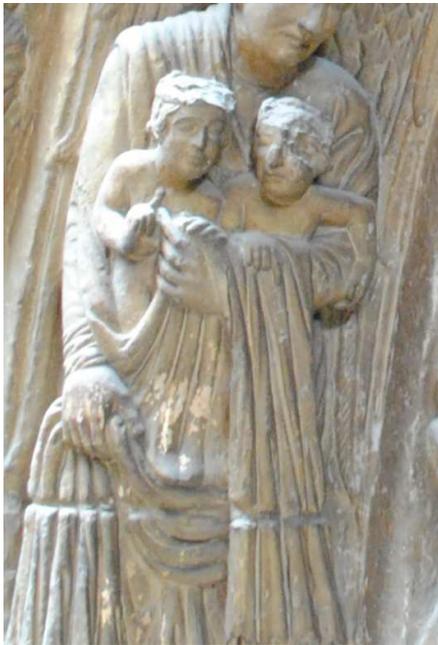
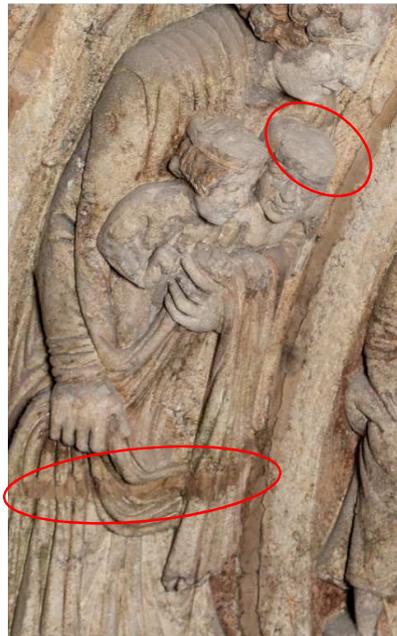
- Some of the pointing and reconstructions on heads on the right arch seems to be later to 1866 as they do not appear in the cast.

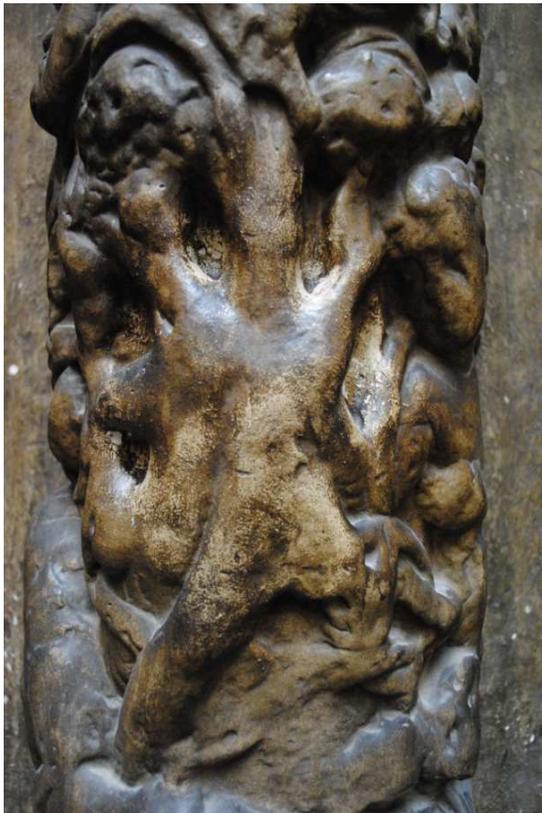
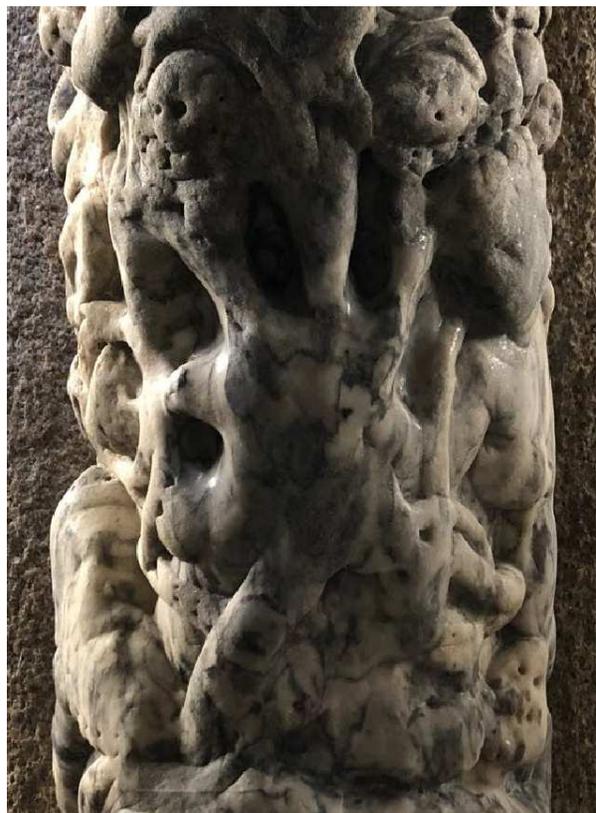
- We could also assess the level of degradation the original Parteluz has suffered since the cast was made over 150 years ago. These area is traditionally touched by pilgrims and visitors when arriving at the Cathedral.
It is possible to see how the original marble has much deeper recesses and loss of detail in comparison with its condition in 1866.

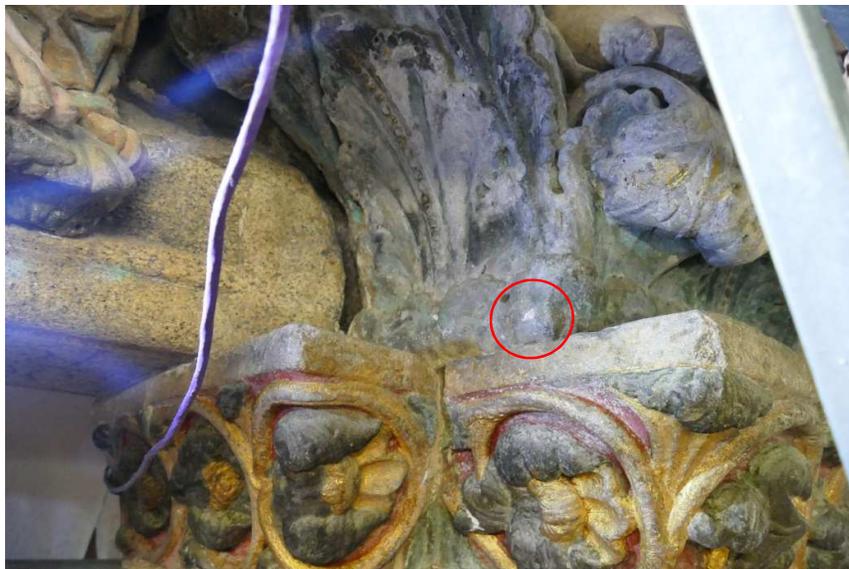
- It became clear that Brucciani did not use gelatine moulds. No traces of gelatine were found on the original Portico. This substance when observed under UV light shows a very particular blue fluorescence. No residues or observations of traces in any of the samples taken from the original were found. This discards the theory of a possible gelatine mould made by Brucciani.
- It was discussed a series of traces of plaster found on the painted surface of the original Portico. These traces were thought to be from the 1866 moulds. Samples were extracted for analysis on different areas such as P73-JBo3-EJ88 on the surface next to the head of the St Bartolome figure (the internal figure on the right pier of the right arch), or sample 315 from the left side of the capital at the top of the central mullion or Parteluz.

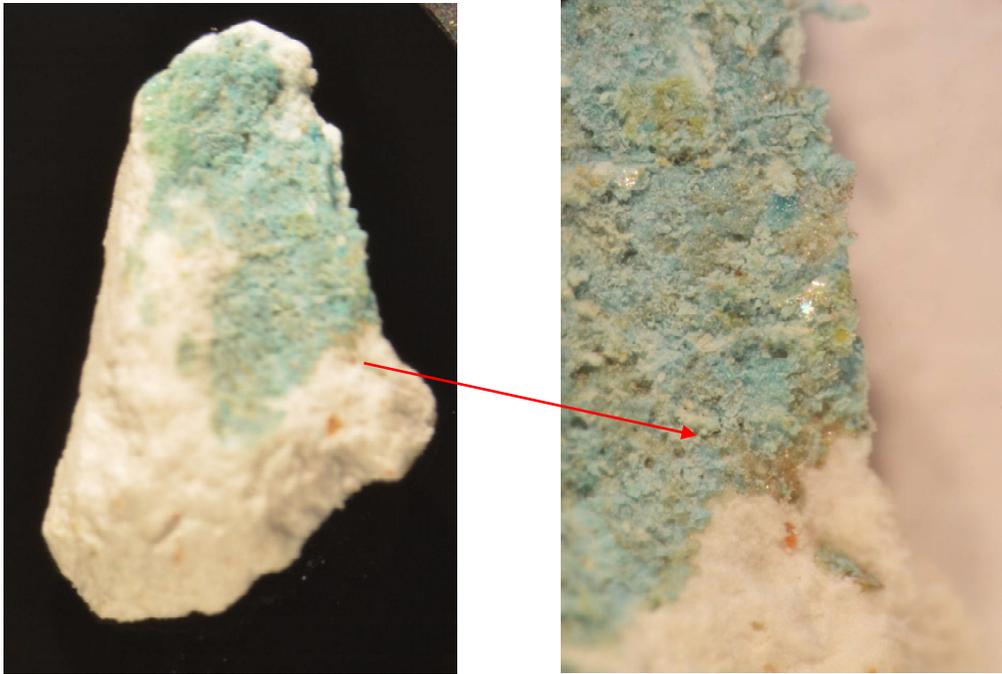
These samples were observed under different magnifications, polarised light and UV light as well as through an electronic microscope that also allowed microanalysis. Some of these samples show a brown uniform layer between the plaster and the paint layer.

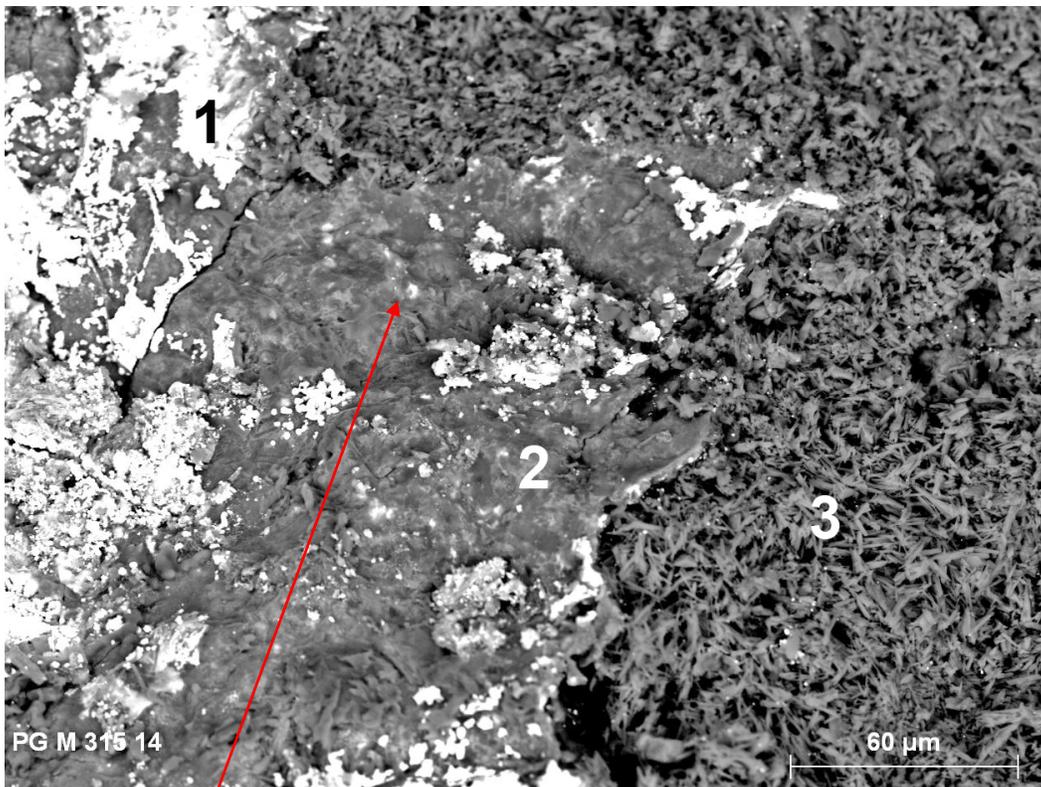
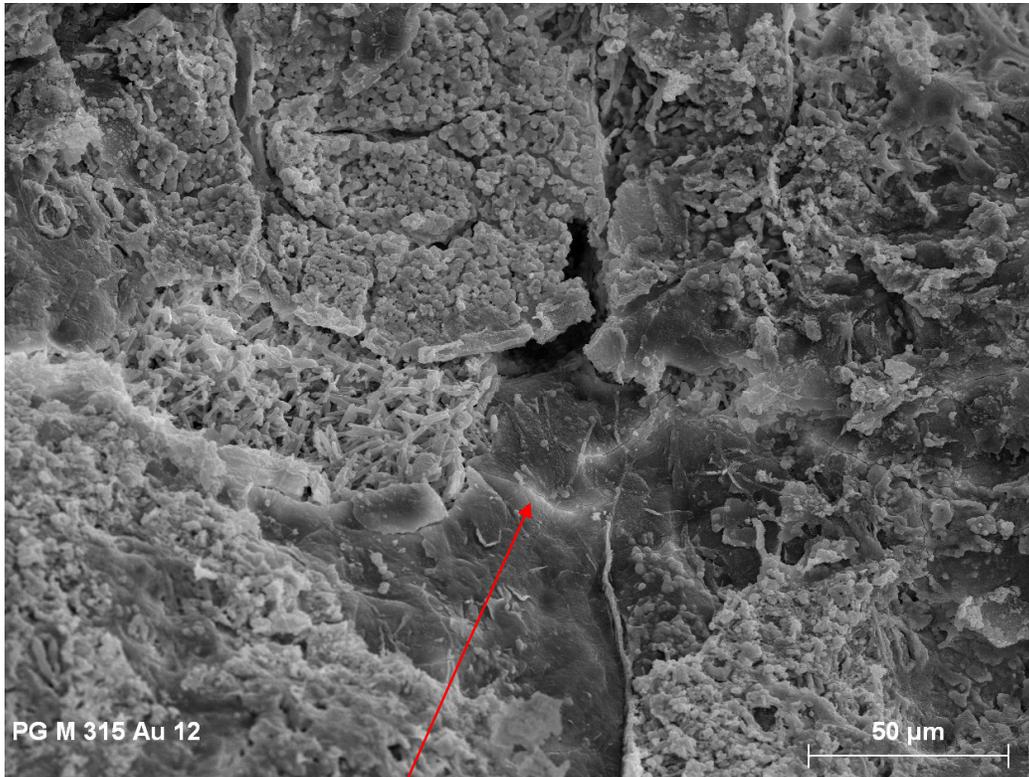
Oxalate layer

This brown very uniform layer found between the polychrome and the plaster seems to be an oxalate. This layer is low on Si and Al, ruling out silicates so it's not clay.

The oxalate probably relates more to biodeterioration, more likely relates to a linseed oil layer as it was left on the surface. This layer would have been over the years altered by an oxidation process of the proteins in the oil helped by the action of microorganisms (lichens, fungal) which converted it on calcium oxalate.

This supports the theory that Brucciani used Linseed oil as a releasing agent for the moulds, and sometimes not using the agreed method with the Cathedral of also applying a layer of cloth for extra protection.

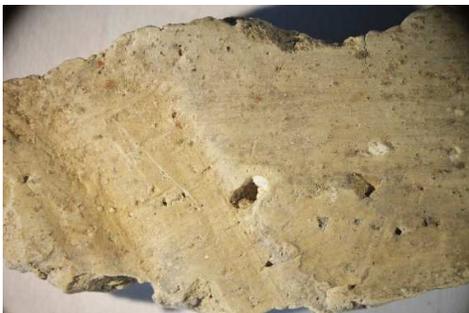
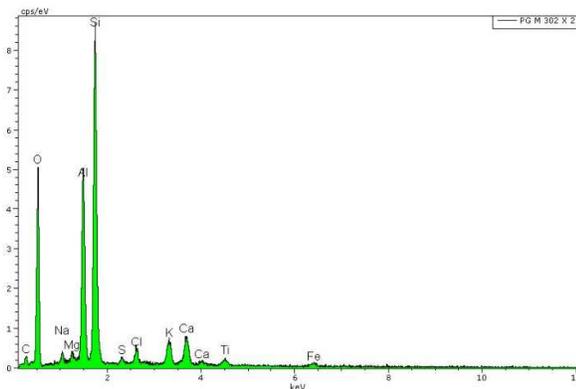
- There are other samples taken with traces of clay such as 314 on the elders from the Timpanum, as well as 306 and 106 from the Timpanum where silicates and Al has been found having very similar pics on the analysis data. This indicates the presence of clay.

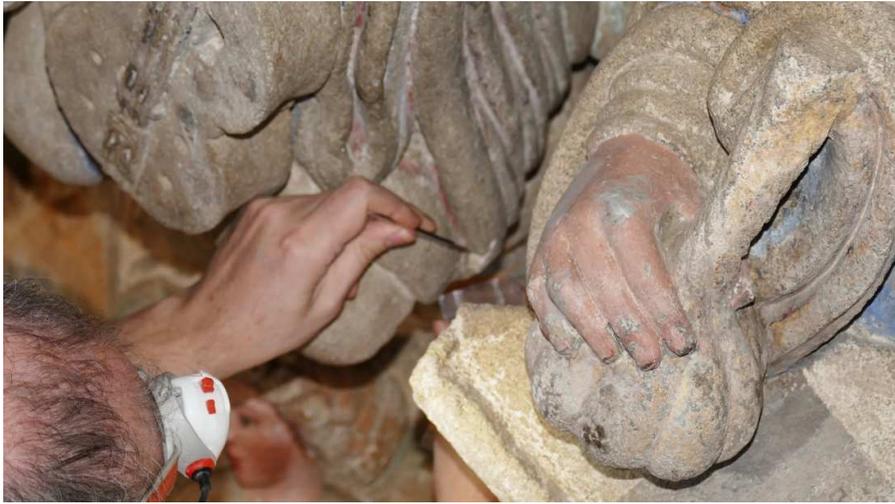
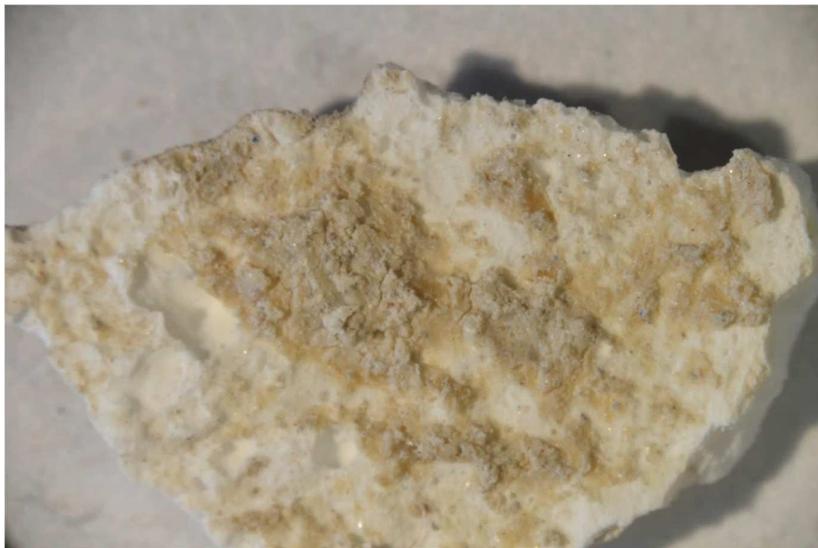
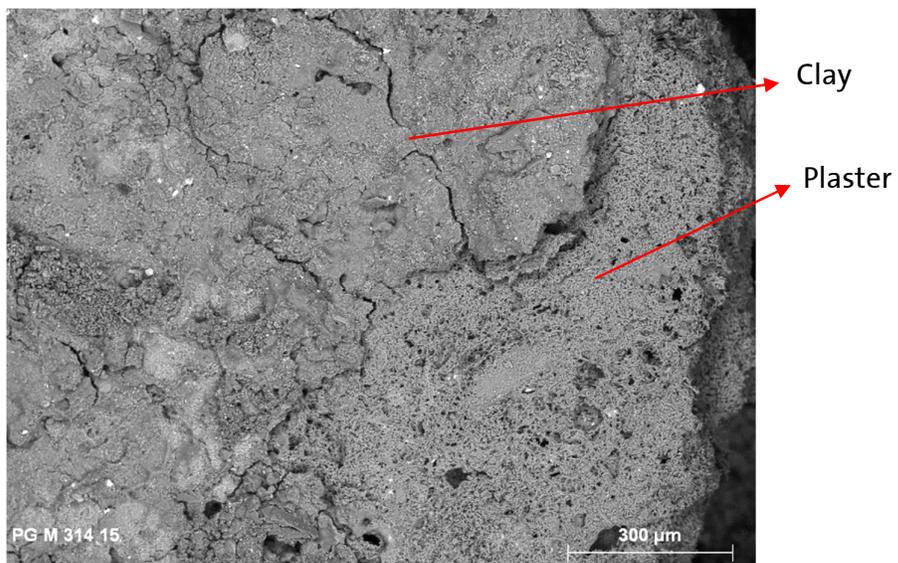
The remains of plaster with clay underneath corresponds most probably to the partition walls constructed to create the plaster parts for the mould.
