ARCHLAB ACCESS REPORT

THE TWO PORTICOS DE LA GLORIA, RESEARCH AND CONSERVATION

Project acronym: 2PORTRECONS

User: Victor Borges. Senior sculpture conservator. Victoria and Albert Museum.

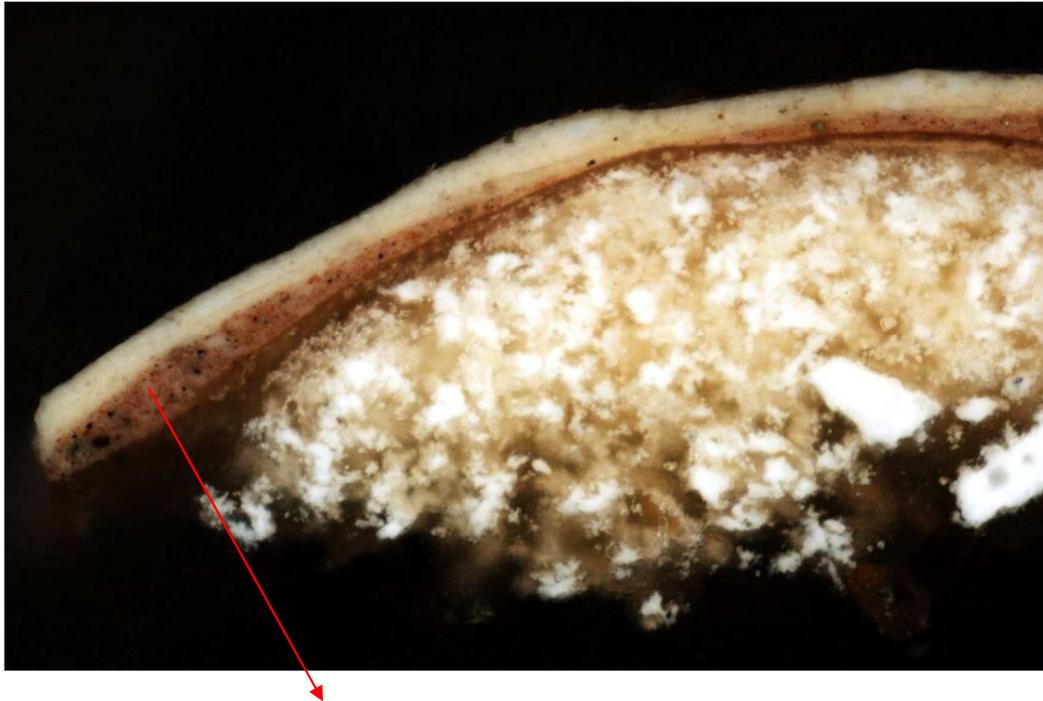
Red layer

- A layer of reddish material was consistently found on the samples analysed from the Cast of the Portico. These traces were thought to be residues of clay from a possible clay mould made by Brucciani.

But the nature of this red layer was found on the Cast surface does not corresponds with the clay found in the original. This layer has a very low or non-existent content of Muscovite and Si and Al from silicates typical of clay; elements that were found on the samples from the original.

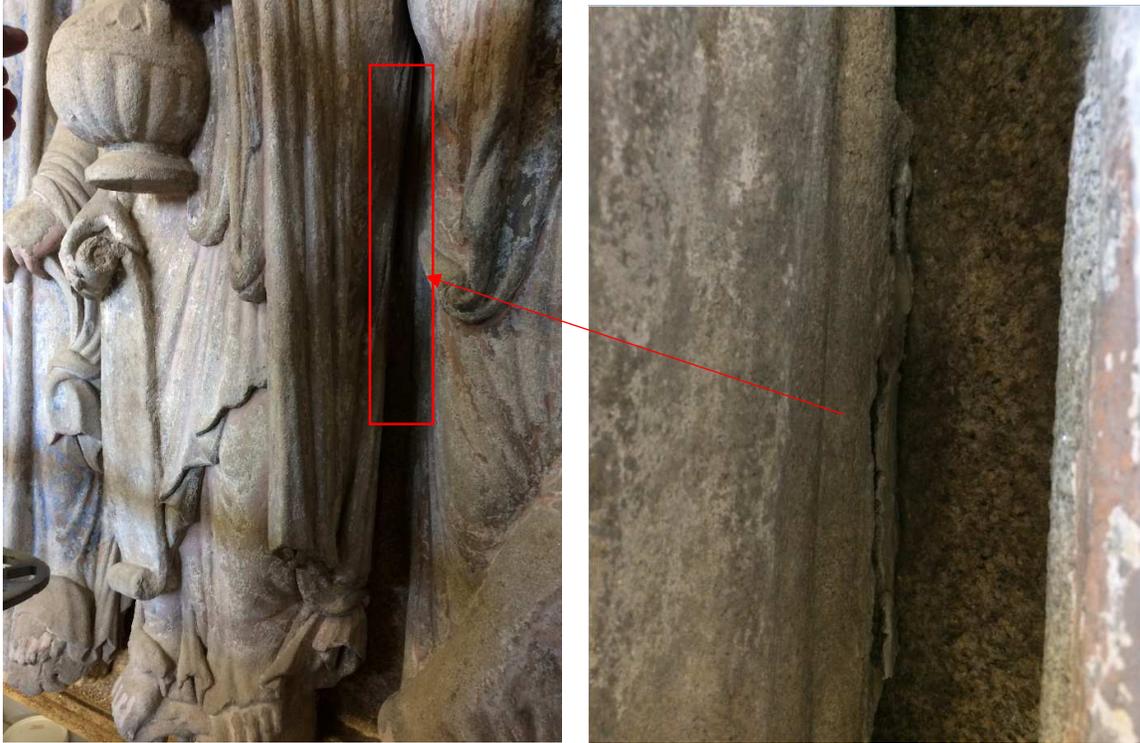
This photo corresponds to clay found behind some of the figures in the tympanum.

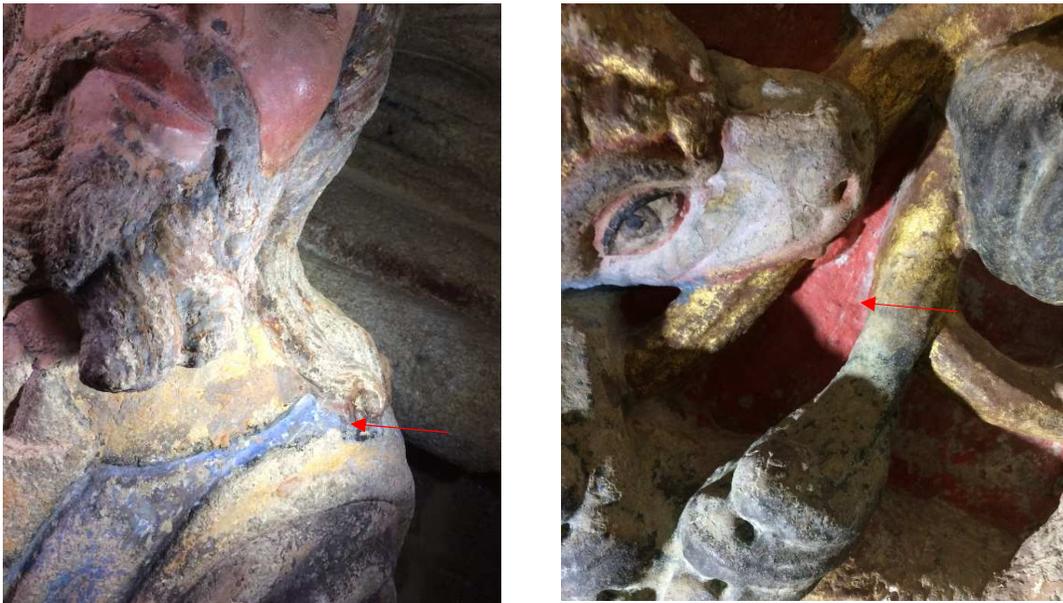
Many incised lines were also observed on the paint layer. This is the consequence of using sharp tools, such as the plasterer's knives to shape and release the plaster pieces for the mould (Pag.7 & 8)
